Manhole Inspection Summary

Manhole # S11MM_017MH

Location Address: **2208 ROSEDALE RD**

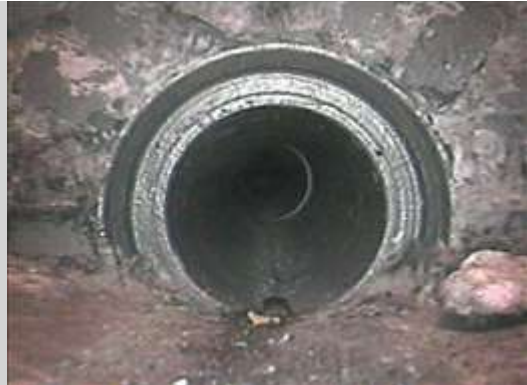
12 O'Clock Outflow

8 in. Circular Gravity Sewer
Pipe Out @ 12 O'Clock

Infiltration: **None** Pipe Seal Cond: **Sound**
